## Prospects for Mitigating the Effects of the Catastrophic Flood on the Vere River through a Temporary Reservoir

Zurab A. Kereselidze, Tengiz V. Kiria, Jemal K. Kiria, Nodar D. Varamashvili,  
Manana M. Nikolaishvili

*Ivane Javakhishvili Tbilisi State University, Mikheil Nodia Institute of Geophysics*

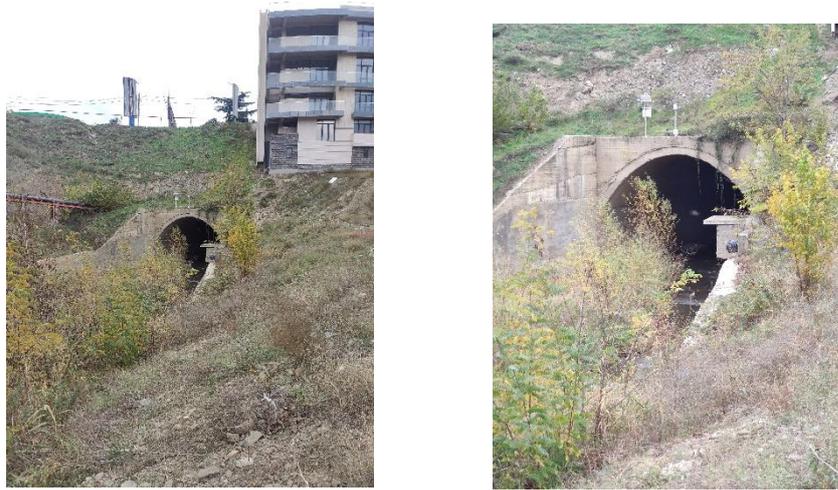
Fig.1. The entrance of the tunnel from Svanidze Street

**Constructive feature.** In the 30s of the 20-th century in the areas of Tbilisi two tunnels (underground bridge) were built on the river Vere. The first tunnel was  $\approx 108$  m (Fig1). The old second tunnel (the old second tunnel is now the third tunnel because a new tunnel was built between the first and the old second tunnel and which (new tunnel) in our paper is referred to as the tunnel2) with the length of  $\approx 700$  m replaced the last section of the natural river-bed at the area before the confluence of the river Mtkvari. The highways passed over the tunnels. In 2010 after finishing the highway building some part ( $\approx 45\%$ ) of the natural river-bed between the inlet of the first tunnel and the river Mtkvari appeared covered due to construction of the new artificial (covered) river-bed. As a result it was a construction, a new artificial covered river-bed, consisting of seven tunnels linked to one another with open segments and had the total length of  $\approx 2100$  m. After the modernization the earlier constructed first tunnel became  $\approx 360$  m long and the old second tunnel –  $\approx 1200$  m. After completion of the construction all the tunnels were semiarch type, had flat concrete basements, compound structure made of reinforced concrete and corrugated steel leaves. It is clear that such an artificial change radically changed the geometry of the river Vere natural bed and, consequently, the hydrological parameters of the valley.

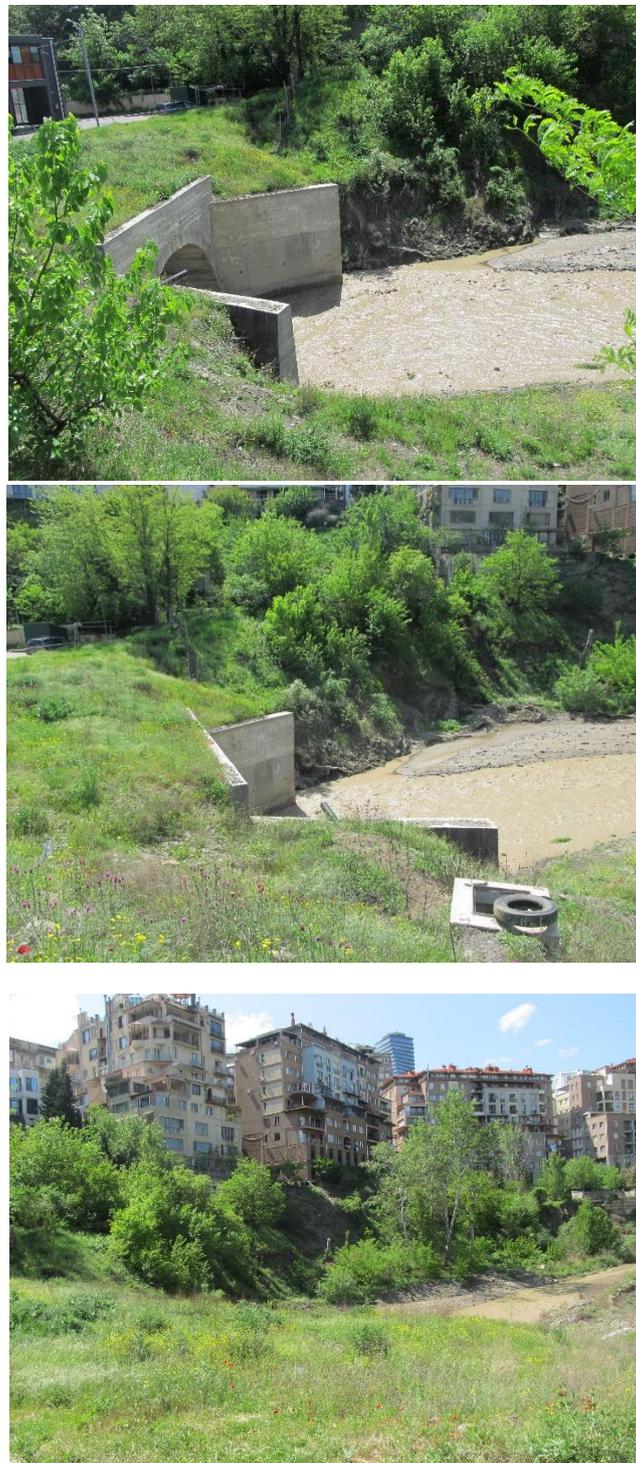
Fig.3. The entrance of the tunnel 2.

[Shergilashvil, 2016]. After the disaster the river-bed was restored in its original form. Only little corrections were made, namely, walls were built before the two tunnels for guiding the water flow. The inlets of these tunnels are located at the points of maximum bending of the open section of the artificial river-bed (Fig. 3. Tunnel 2). The open section of the  $\approx 30$  m long artificial river-bed before Tunnel 2 (Fig.3) bends to that extent that the tunnel is practically located perpendicularly to the river flow. Therefore, supposedly, in the case of increase in the water level the area between the guiding walls will become the problem area of the closed river-bed (water stagnation zone). In this case the effect of the guiding walls can be transformed in hydrodynamic funnel effect and it will additionally reduce the water flow rate in the tunnel.

**The problem of Kipshidze street section.** Thus, in terms of the future danger, we consider the problem of temporary water reservoir between Tamarashvili Highway and Gabashvili Streets to be especially topical. We built a computer model of this section of the gorge in case of its overflowing (Fig. 4). To convincingly calculate the volume of water accumulated in the gorge, we divided this part of the valley, from the exit of the first tunnel (Fig. 2) to the entrance of the second tunnel (Fig. 3), downstream into 34 parts (Fig. 4).
